Interstate Mold Inspection Report S A M P L E ... R E P O R T

Client(s): Sam Powell

Property address: 123 Main street

Inspection date: Thursday, December 04, 2014

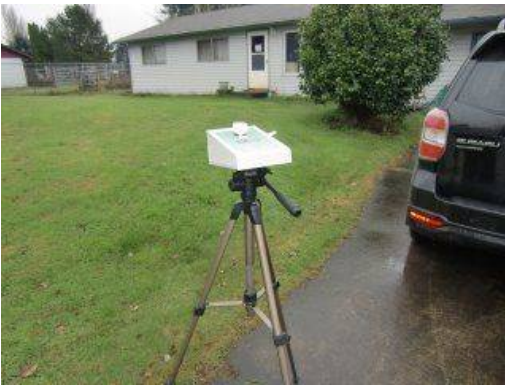
Photo 1-1
Outside air cell outside front of subject house

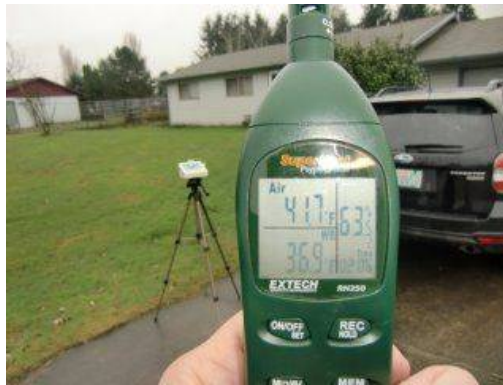
Photo 1-2
Temperature and humidity recorded

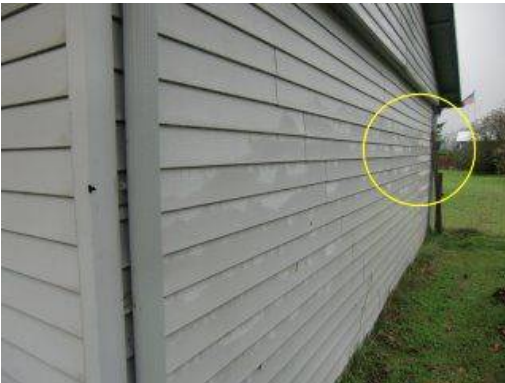
Photo 3-1

sections of siding and/or trim were deteriorated. This may increase moisture in the building. A qualified person should repair, replace or install siding or trim as necessary.

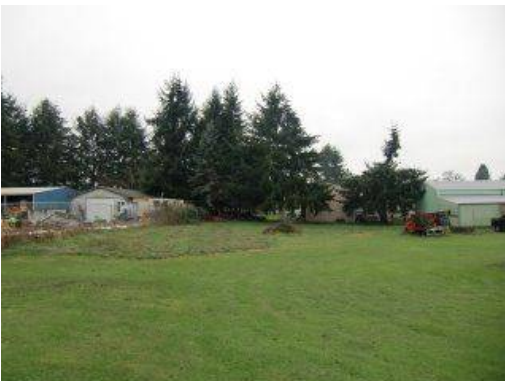
Photo 4-1

The perimeter grading sloped towards the building in one or more areas. This may increase moisture in and around the building. Recommend grading soil so it slopes down and away from the structure with a slope of at least 5% (10% or better is optimal) for at least 6 feet.

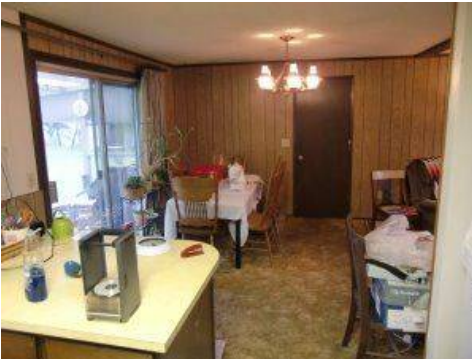
5) The client said the living room / dining area had a musty odor and an intense inspection revealed no microbial growth in this area.

Photo 5-1
Dining area and living area.

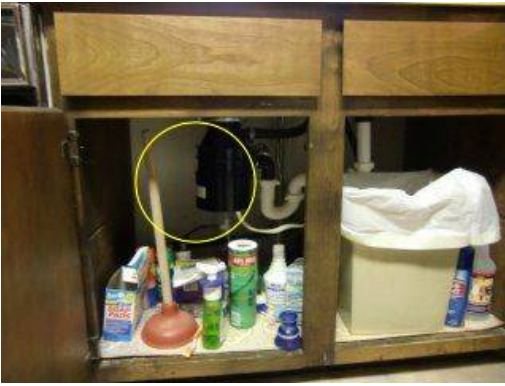
Photo 6-1

This area under the kitchen sink has a slight mold infestation on the wall behind the disposal. It is approx. 12" X 10". a tape lift was taken at the base of the wall. The results are attached with this report.

This area under the kitchen sink has a slight mold infestation on the wall behind the disposal. It is approx. 12" X 10". a tape lift was taken at the base of the wall. The results are attached with this report,

It was recommended that the home owner have the section of wall removed by a licensed contractor or mold remediation contractor.

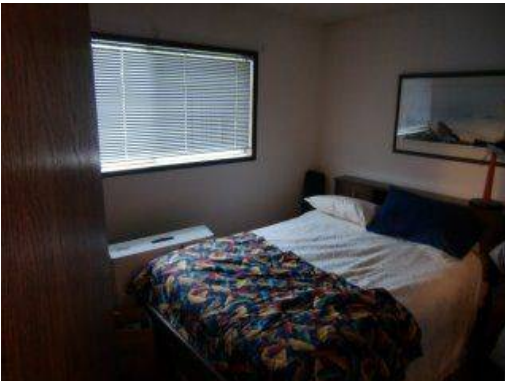
Photo 8-1

Stains and elevated levels of moisture were not found on all walls and ceiling areas

This room was free of any high moisture on exterior walls, and microbial growth.

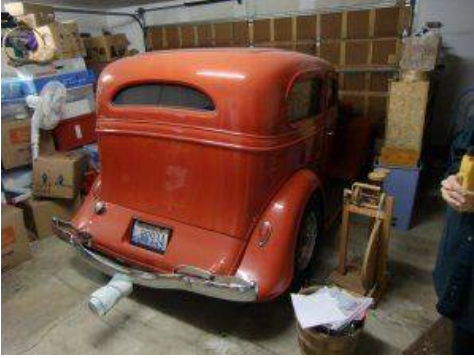
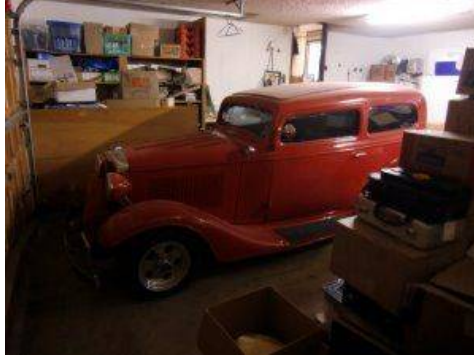
9) 🗨️🔍👤 This inspector had some concern over mustiness in the garage, however, due to property blockages, a full inspection was not possible at this time.

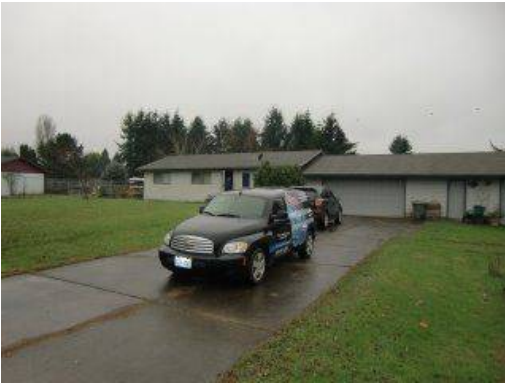
10) The outside sampling was conducted in the front area of the home near the driveway. Equipment set at 10 minutes at 150 m/L. Due to the continual light rain the majority of mold spores in the air have dropped to the ground.

Photo 10-1
Clients home. 3 air O Cells taken

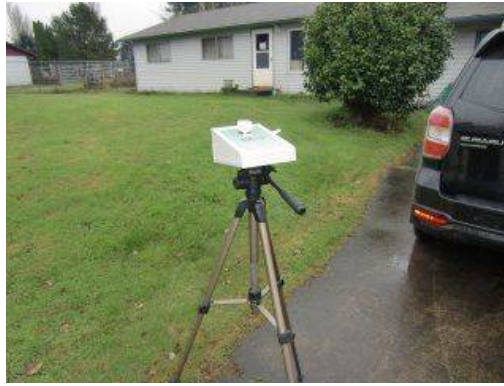
Photo 10-2
Outside air cell outside front of subject house

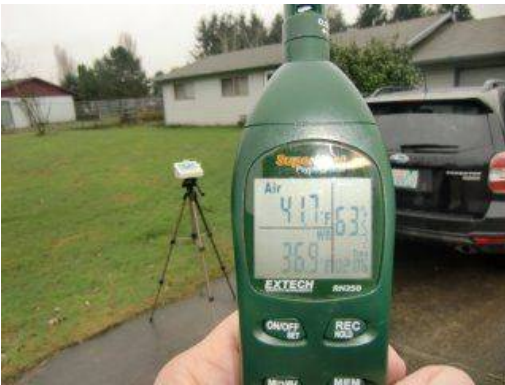
Photo 10-3
Temperature and humidity recorded

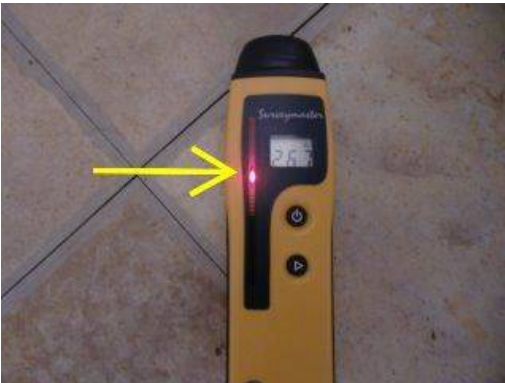
Remediation Recommended: It is the recommendation of this certified inspector that although the mold spore Count inside the subject property was not very high and no mold infestations were found, the moisture readings on the floor of the hallway bathroom were extremely high. The client stated that there had been no showers or baths taken in that room in a couple of days therefore there was no reason for the high moisture content on the linoleum. It is recommended that a contractor or mold remediation company evaluates the floor and if needed remove the subfloor and inspect for dry rot and mold infestation. Once this has been completed then interstate mold inspection can return before the subfloor is reinstalled and inspect for mold.

Photo 11-1
Moisture reading medium to high.
Recommend that a qualified contractor or Remediation company evaluate the sub floor and check for wood rot and mold infestations.

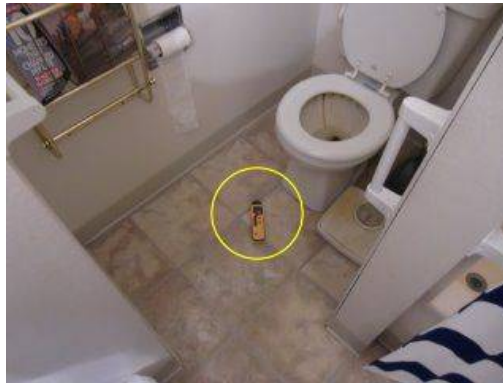
Photo 11-2
Location of moisture readings

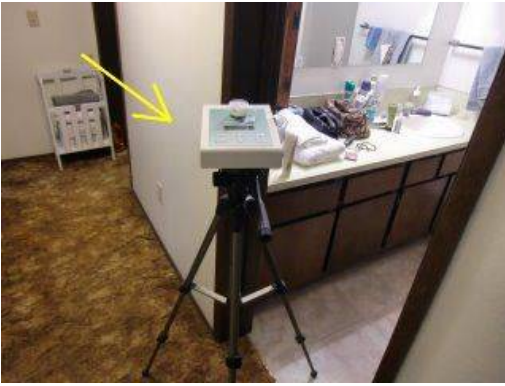
Photo 11-3
Air O Cell sampling located in Hallway

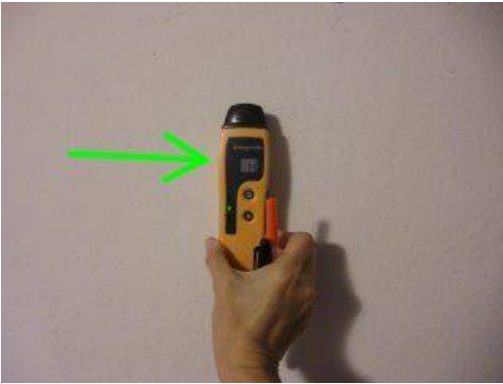
13) 🔍🏠 A through inspection in this room revealed no microbial growth, and all walls showed very low or non existent moisture readings.

Photo 13-1
Moisture readings on exterior walls very low in this area

It is recommended that the homeowner monitor this area and watch for any growth along exterior walls.

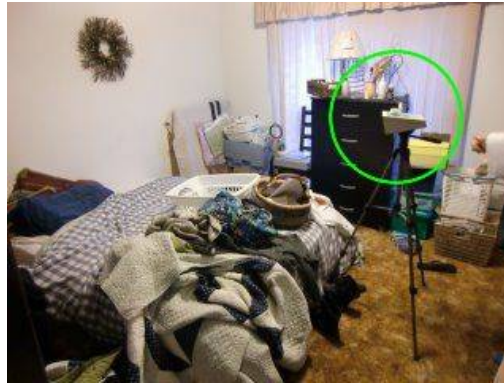
Photo 13-2
Master bedroom with air sampling equipment in place extracting breathable air at a rate of 150 m/L

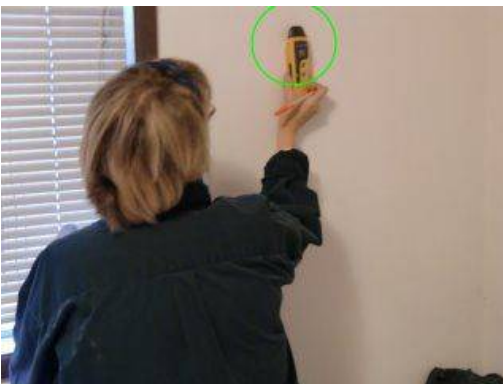
Photo 13-3
Exterior wall moisture reading very low. No concerns

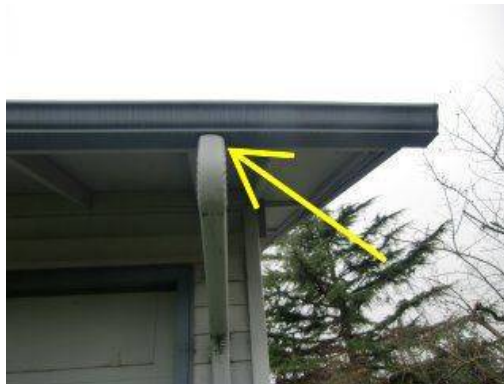
Photo X-2
Gutters are in good working order and
troughs are clean

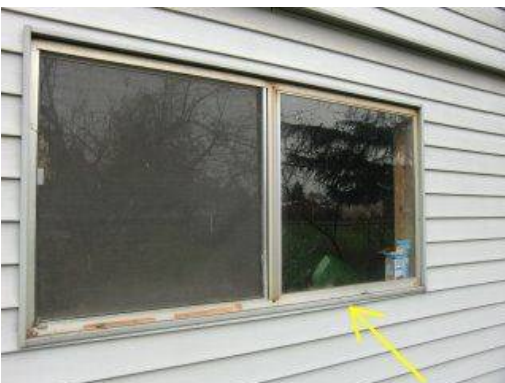
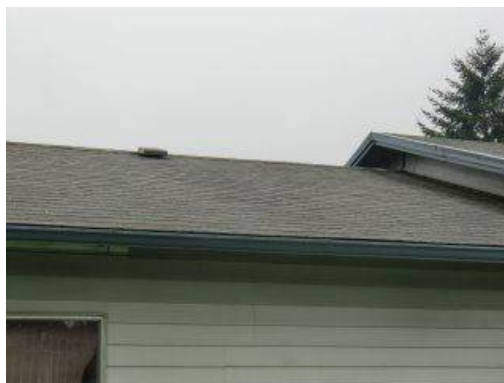
Photo X-3

Windows are vinyl framed and susceptible to mold from condensation
